## TYPE ASSESSMENT AND TEST REPORT

| Report Reference number: | MTEEx 1997/22.0542B |
| Test Item description: | Enclosure |
| Model/Type reference: | Hawk Housing |

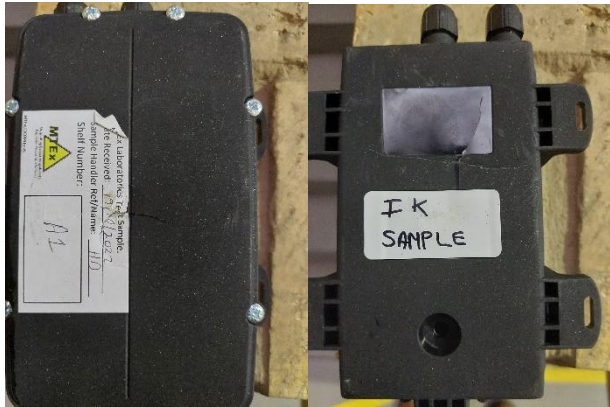
| Clause | Requirement – Test | Result – Remark | Verdict |
|---|--|---|---|
| 6.3 and 6.4 | <p>One sample was mounted on the concrete floor and impacted five times on all sides until visual damage was observed that will impair the ingress protection, the maximum impact observed that caused this damage was 1kg from a height of 0.5m with an impact energy of 5J.</p> | | <b>IK Code assigned: IK08.</b> |
