# 10 Year Maintenance Plan

123 Smith Street

Strata Plan 1000

Inspection date:	1/12/2023
Inspector:	John Smith

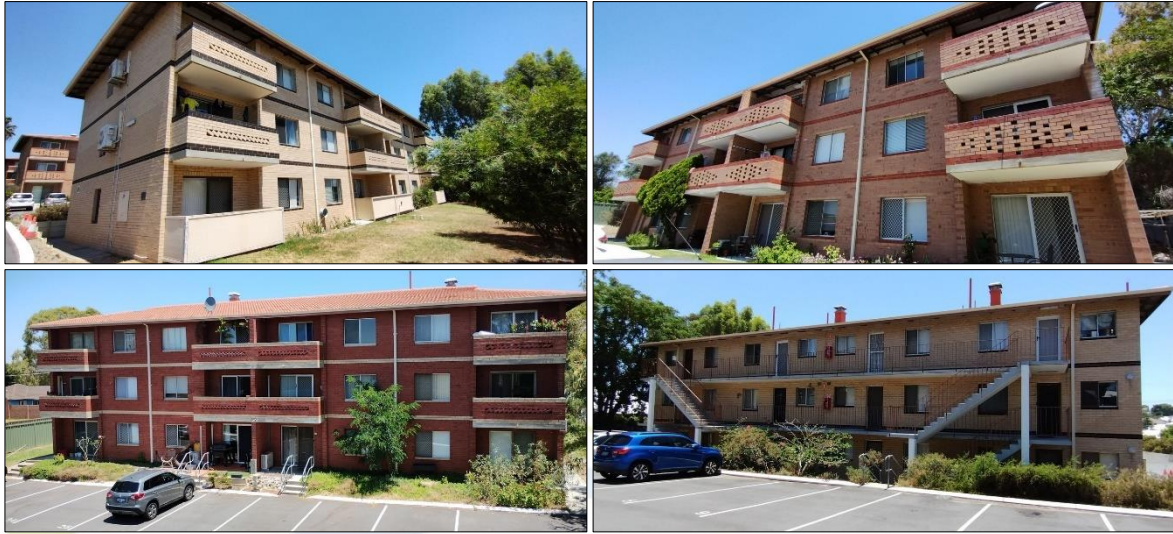
### BUILDING EXTERIOR

Overall condition - fair. There was a variety of conditions amongst building elements within this category. Items such as downpipes and gutters appeared to be in good condition, whilst the fascia and metal balustrades were of poor condition.

7. **PAINTED METAL** - Some painted metal items show signs of wear and/or damage. Repainting these items is recommended in the short term, but full replacement of these items should be considered and planned for well in advance.

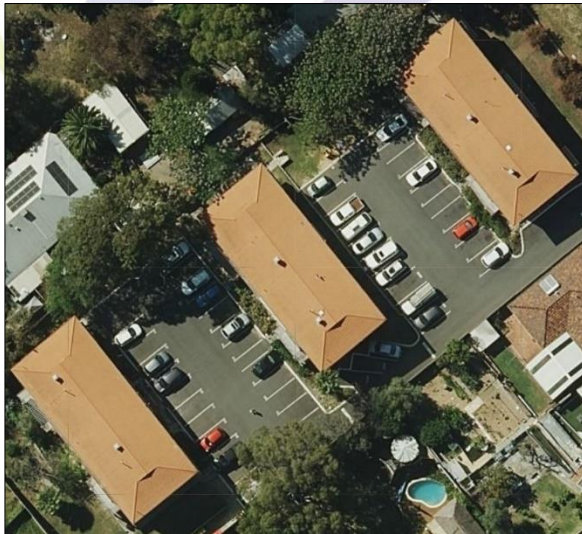
### ROOFTOP

Inspector was unable to comment on the roof condition as the area was not inspected.

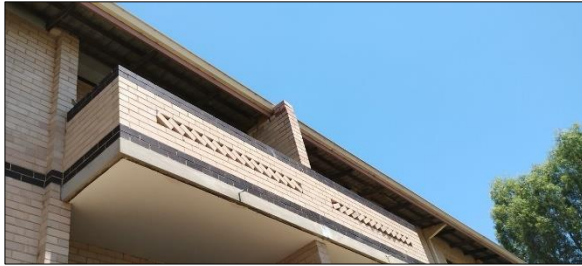
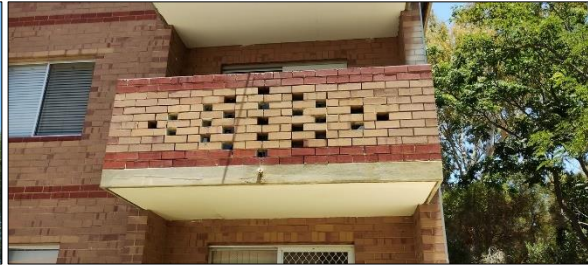
**ACCESS FOR WORK AT HEIGHTS**

Overall condition - poor. Urgent repointing to sections of brickwork are required (notably the balustrades on upper floor levels). These areas are a safety hazard, and reinstatement of these building components in the near future is recommended.

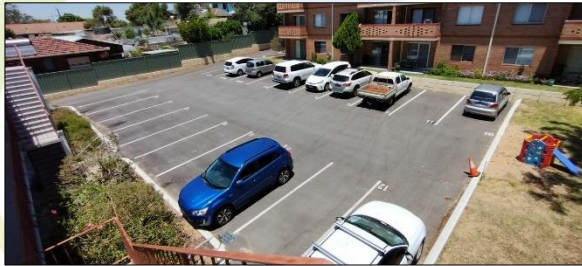
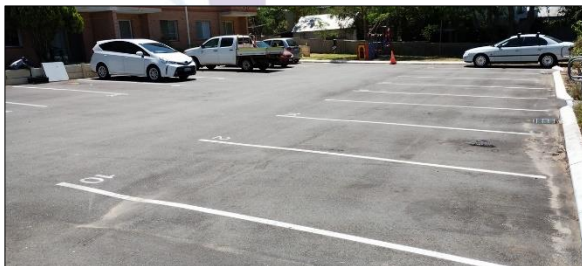
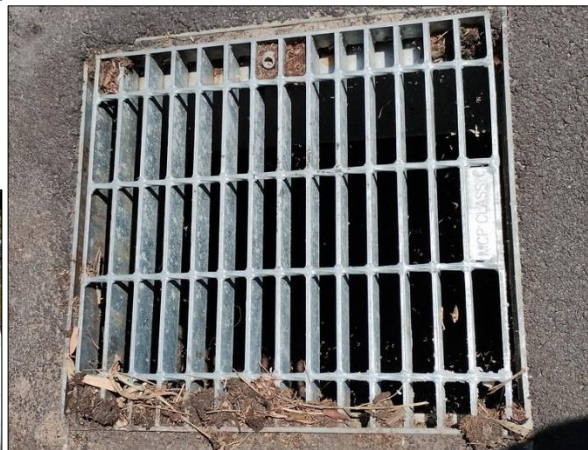
**VEHICLE ACCESSWAYS**

Overall condition - good. The vehicle accessway surface is in good condition and line markings appear bright. Paint highlighting to the perimeter of the drain grates is recommended as it helps prevent a safety hazard to those wearing high and/or narrow heels.

8. **BITUMEN SURFACES** - Bitumen surfaces are more susceptible to environmental factors than other areas of the property. It is important that any deterioration is addressed promptly, as the deterioration of bitumen tends to accelerate when not maintained, significantly increasing overall maintenance costs.

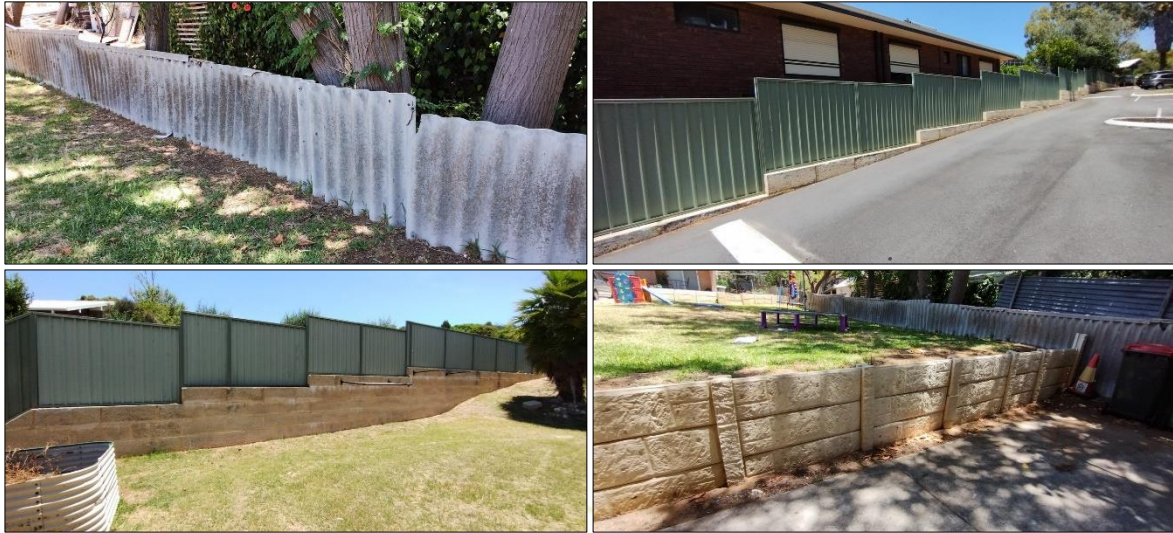
**FENCING AND WALLS**

Overall condition - fair. Some areas of the boundary fence were in poor condition (notably the northern end of site), whilst other sections of fence were in good condition.

9. **BOUNDARY FENCES OR WALLS** - Maintenance of fences or walls between properties is regulated under the Dividing Fences Act 1961, which states that neighbours have equal responsibility for dividing fences or walls (excluding retaining walls). As such, a 50% rate has been used for all maintenance work on boundary fences or walls.

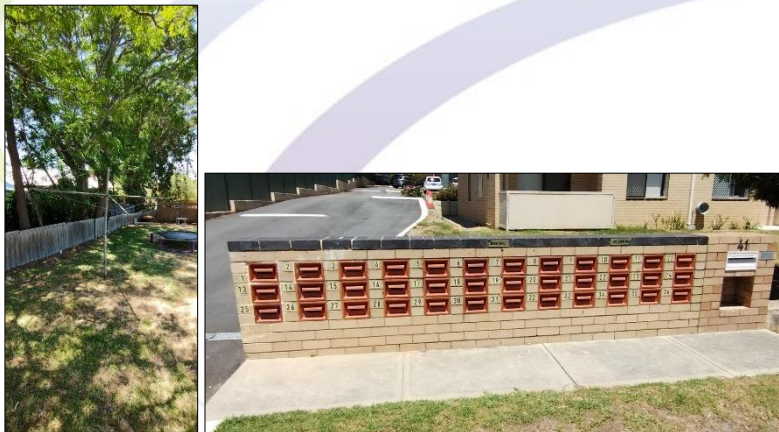
**FIXTURES & FITTINGS**

Overall condition - fair. The majority of the rotary clothes lines were off centre and tilted to one side. Replacement is recommended.

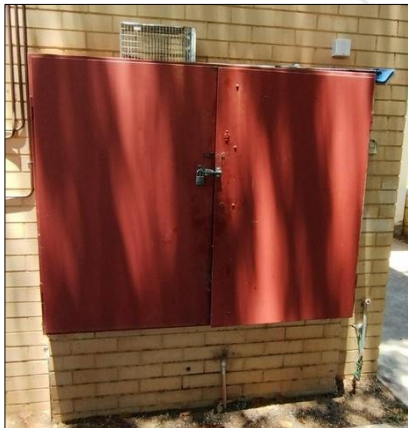
**ELECTRICAL**

Inspector was unable to comment on the electrical switchboard condition as the area was inaccessible on the day of inspection.
