## IP TEST REPORT

Report reference number:	MTEEx 1958/22.0486
Date Tested:	2022/09/18
Date Report was issued:	2022/10/05
Standards.....:	SANS 60529:2013 "Degree of protection provided by enclosure (IP Code)."
IP rating obtained after testing:	IP 68
Applicant's Company Name .....	Digital Matter Embedded (South Africa)
Applicant's reference.....:	COD
Device.....:	G70 Rugged Housing
Address.....:	No.7 Pinetree Business Park 63 Brahman Crescent Westfield 1610
General remarks:	<ul style="list-style-type: none"> <li>- The test results presented in this Test Report relate only to the item or product tested.</li> <li>- "(see Attachment #)" refers to additional information appended to this document.</li> <li>- "(see appended table)" refers to a table appended to this document.</li> <li>- Throughout this document, a point "." is used as the decimal separator.</li> <li>- This report/certificate shall not be reproduced except in full.</li> </ul>

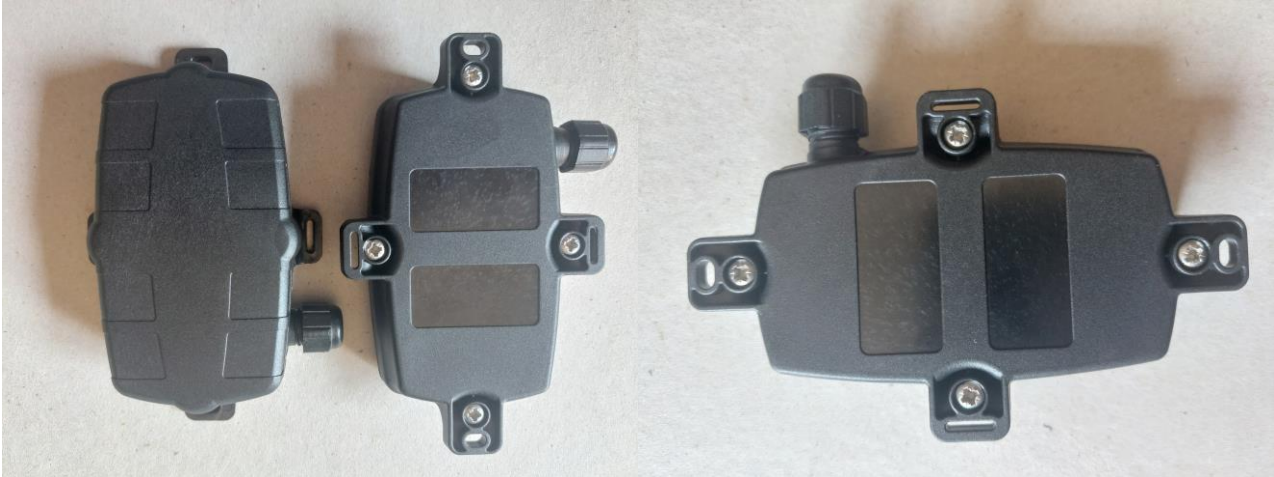
## 1. DESCRIPTION OF SAMPLE

The enclosure was manufactured from PA6/GF15 Nylon Glass Compound. The enclosure had the following overall dimensions: 25mm x 65mm x 110mm (Assembled). The enclosure consisted of two main parts, held together by means of four Philips head self-tapping screws. A sealing element was fitted to one part of the enclosure on the inside of the fasteners. A gland formed part of the moulded construction.
