## TYPE ASSESSMENT AND TEST REPORT

| Report Reference number: | MTEEx 1997/22.0542B |
| Test Item description: | Enclosure |
| Model/Type reference: | Hawk Housing |

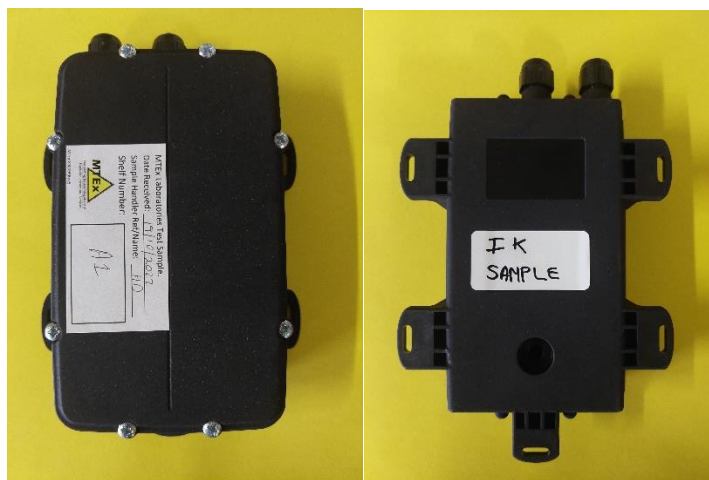
The enclosure was manufactured from PA6/GF15 Nylon Glass Compound. The enclosure had the following overall dimensions: 39.19mm x 182.63mm x 118.5mm (Assembled). The enclosure consisted of two main parts, held together by means of eight Philips head self-tapping screws. A sealing element was fitted to one part of the enclosure on the inside of the fasteners. A gland formed part of the moulded construction.
