TYPE ASSESSMENT AND TEST REPORT				
Report Reference number:	MTEX/1958/22.0486B			
Revision:	0			
Reason for Review:	N/A			
Date of issue:	2022-10-05			
Ex Testing Laboratory (ExTL):	Megaton Systems (Pty) Ltd T/A MTEx Laboratories.			
Ex Certification Body (ExCB):	Unit 1 Weirda Place, 17 Hilda AV, Hennopspark, Centurion,			
	South Africa, 0157.			
Manufacturer's name:	Digital Matter Embedded (South Africa)			
Address:	NO.7 Pinetree Business Park			
	63 Brahman Crescent			
	Westfield			
	1610			
Trademark:	N/A			
Standard associated with this ExTR:	IEC 62262: 2002-02 First edition			
	Degrees of protection provided by enclosures for electrical			
	equipment against external mechanical impacts (in code)

- <u></u>			
Test procedure(s):	All the ExTL's Test Procedures associated with the Clauses			
	above.			
Test Item description:				
Model/Type reference:	G70 Rugged enclosure			
IK Code:	_IK			
Electrical Ratings:	Empty enclosure tested			
Rated Ambient temp range:	20 to 40 °C			
Sample/Serial Number:	_N/A			
Additional Marking (e.g. IP):	N/A			
All testing fully performed by ExTL staff at ExTL address above:				
Yes.

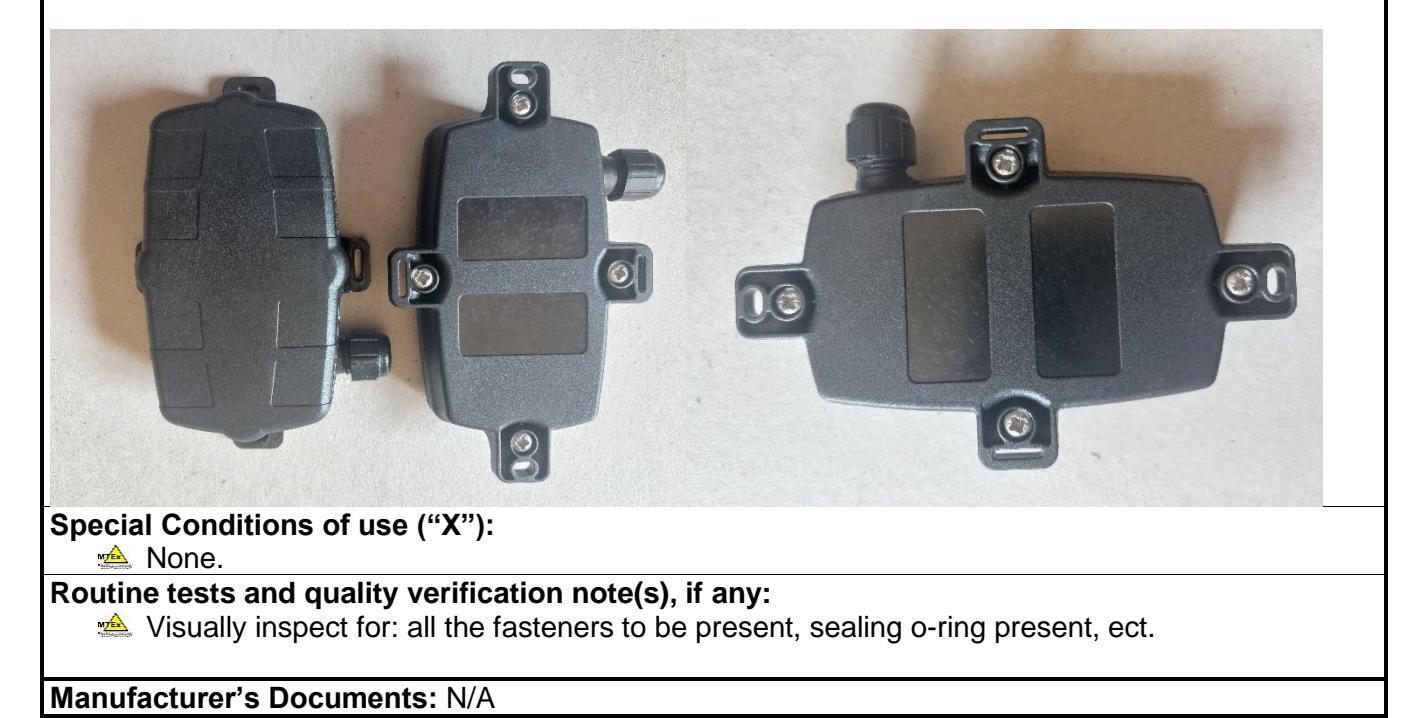
The enclosure was manufactured from PA6/GF15 Nylon Glass Compound. The enclosure had the following overall dimensions: 25mm x 65mm x 110mm (Assembled). The enclosure consisted of two main parts, held together by means of four Philips head self-tapping screws. A sealing element was fitted to one part of the enclosure on the inside of the fasteners. A gland formed part of the moulded construction.

6.3 and 6.4	One sample was mounted on the concrete floor and impacted five times on all sides until visual damage was observed that will impair the ingress protection, the maximum impact observed that caused this damage was 1kg from a height of 0.5m with an impact energy of 5J.
